STEGE SANITARY DISTRICT

Calendar Year 2019 Performance Report

JANUARY 2020

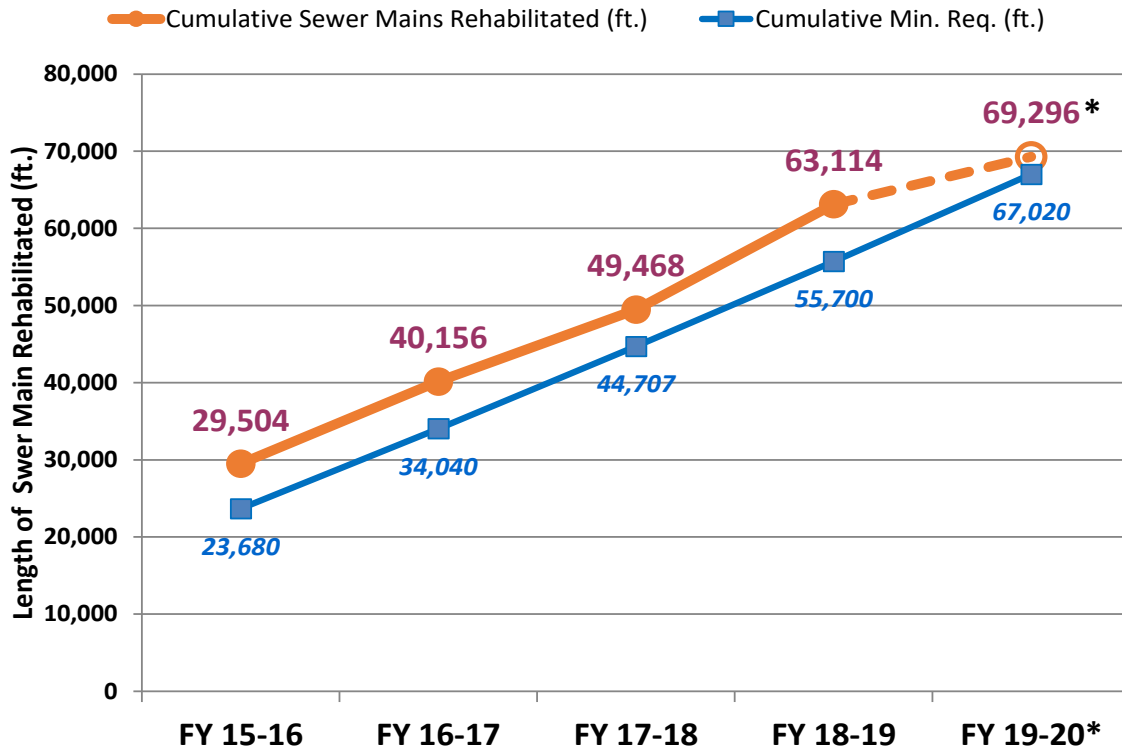
TABLE 14

The minimum requirement, per the USEPA Consent Decree, is to complete rehabilitation of 23,680 feet of sewer main by the end of FY 2015-16 and to continue at no less than the feet of sewer main stated in the Consent Decree Appendix based on a cumulative total (e.g., 34,040 feet by June 30, 2017; 44,707 feet by June 30, 2018; etc.) for the duration of the Consent Decree.

Sanitary Sewer Main Rehabilitation

ASSESSMENT: As shown in Table 14, the District’s cumulative rehabilitation total was well above the required cumulative rehabilitation total of 55,700 feet at the end of FY 18-19. For the current FY 19-20, the cumulative rehabilitation total is already ahead of the Consent Decree requirement of 67,020 feet and there are still 6 months and ~45% of the budget remaining before the end of the fiscal year. As shown in Table 15, the rehabilitation cost per foot was \$192 in FY 2018-19 which is the average of the previous 2 years. The rehabilitation cost per foot for the current FY 2019-20 has increased to \$240, but is incomplete as the capital improvement project is still ongoing. Engineering staff will continue to try to stay ahead of the required rehabilitation total and manage projects accordingly to protect against sudden increases to construction costs that our neighboring agencies are currently experiencing.
